NASA Technical Memorandum TM 107552

Debris/Ice/TPS Assessment And Integrated Photographic Analysis For Shuttle Mission STS-46

September 1992

Gregory N. Katnik
NASA/Kennedy Space Center

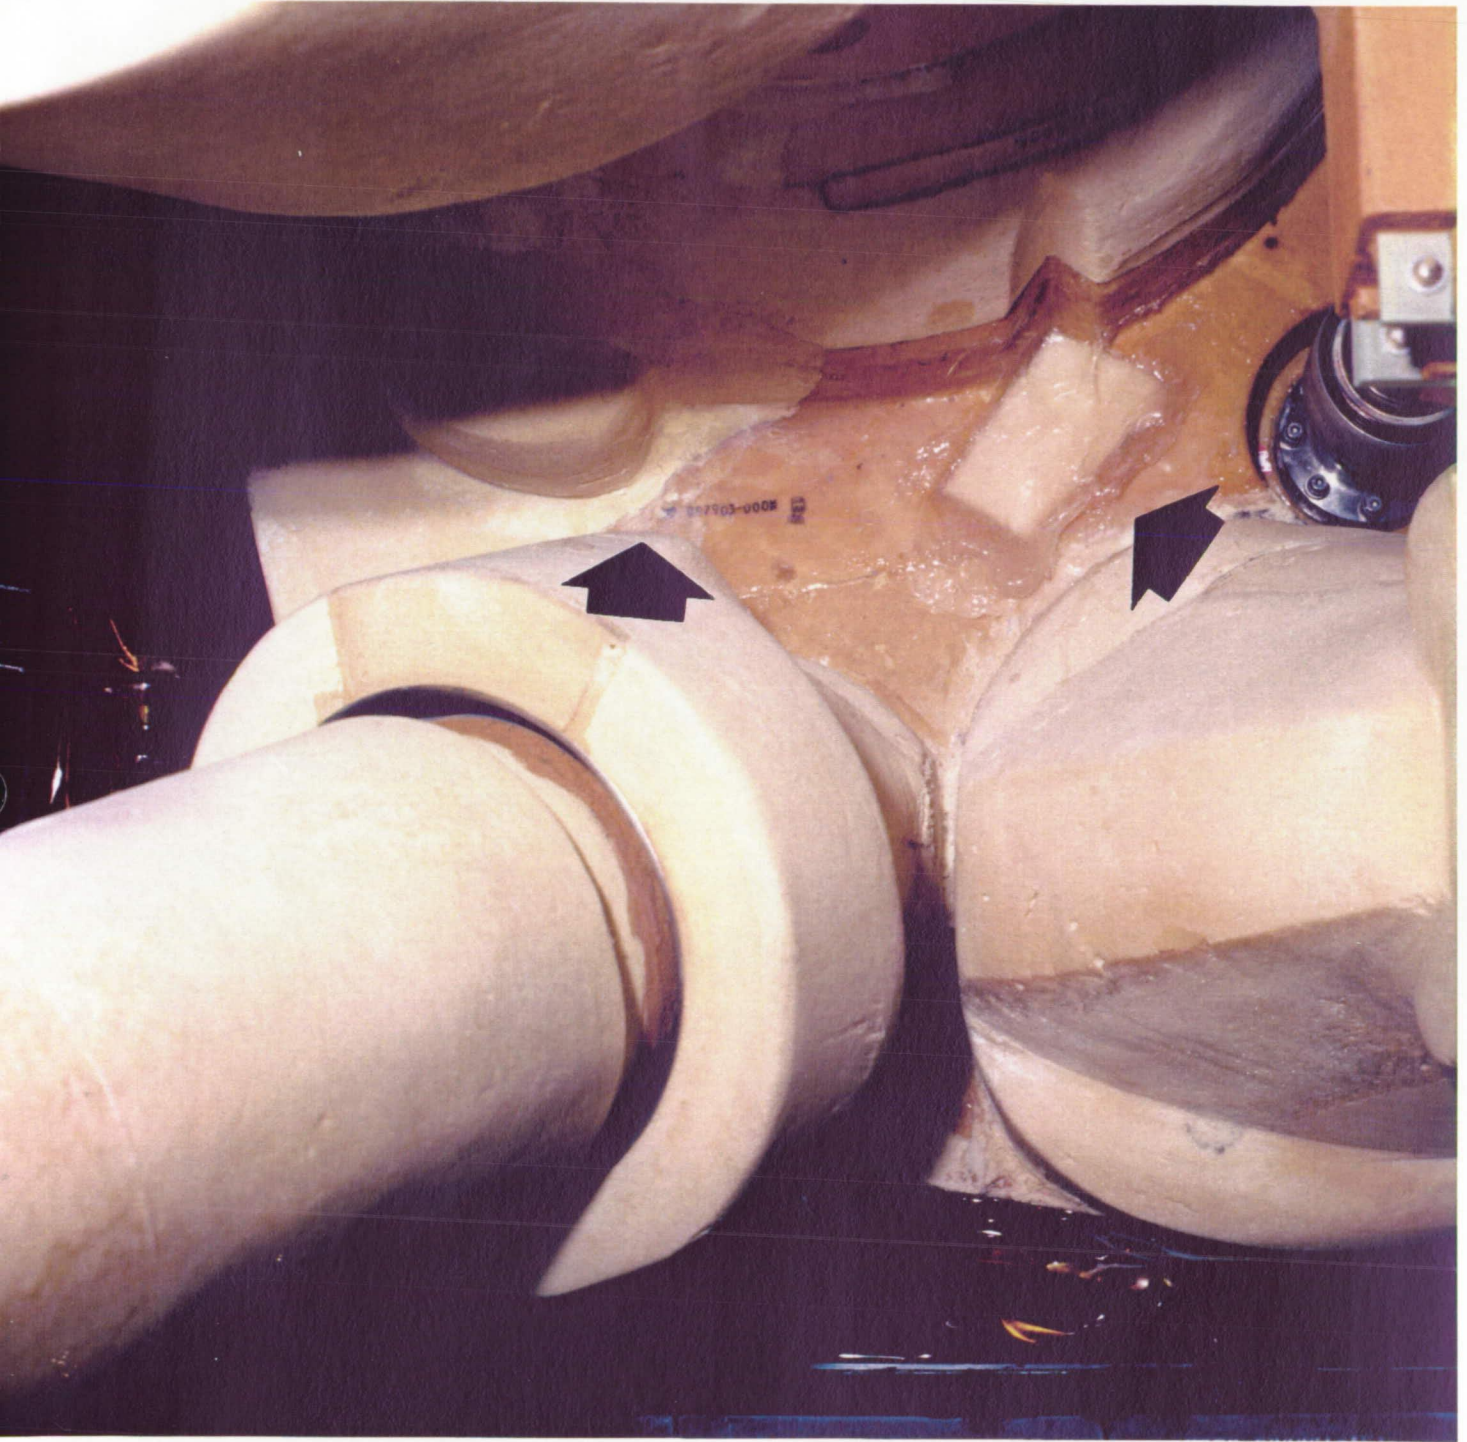
LH2 ET/ORB umbilical, including aft pyrotechnic canister closeout and 17-inch flapper valve actuator access port foam plug closeout, prior to cryogenic fuel loading.

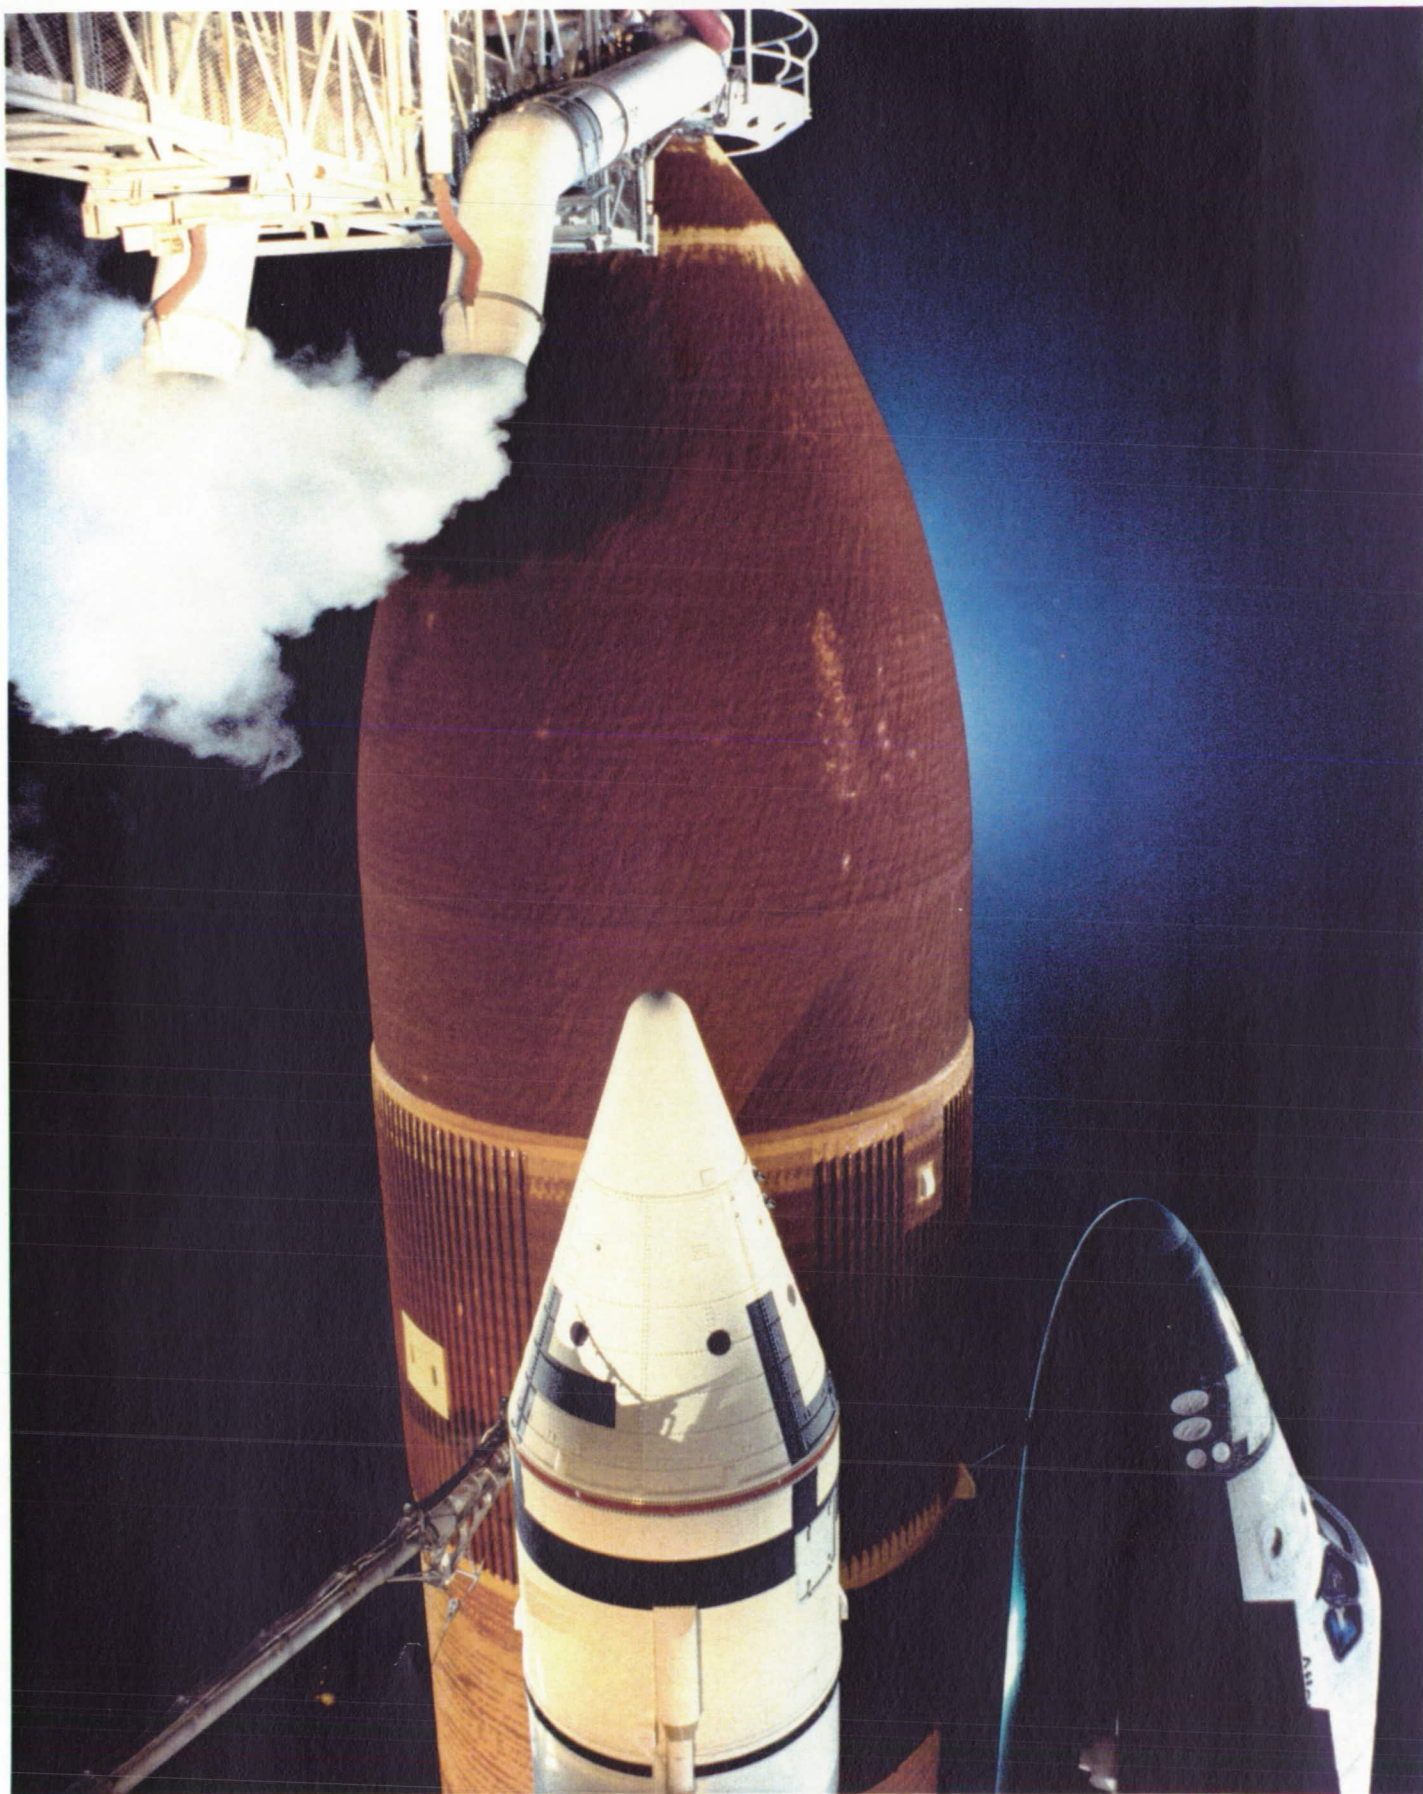
Light condensate, but no ice or frost accumulation, was present on the ET LO2 tank ogive and barrel section TPS acreage

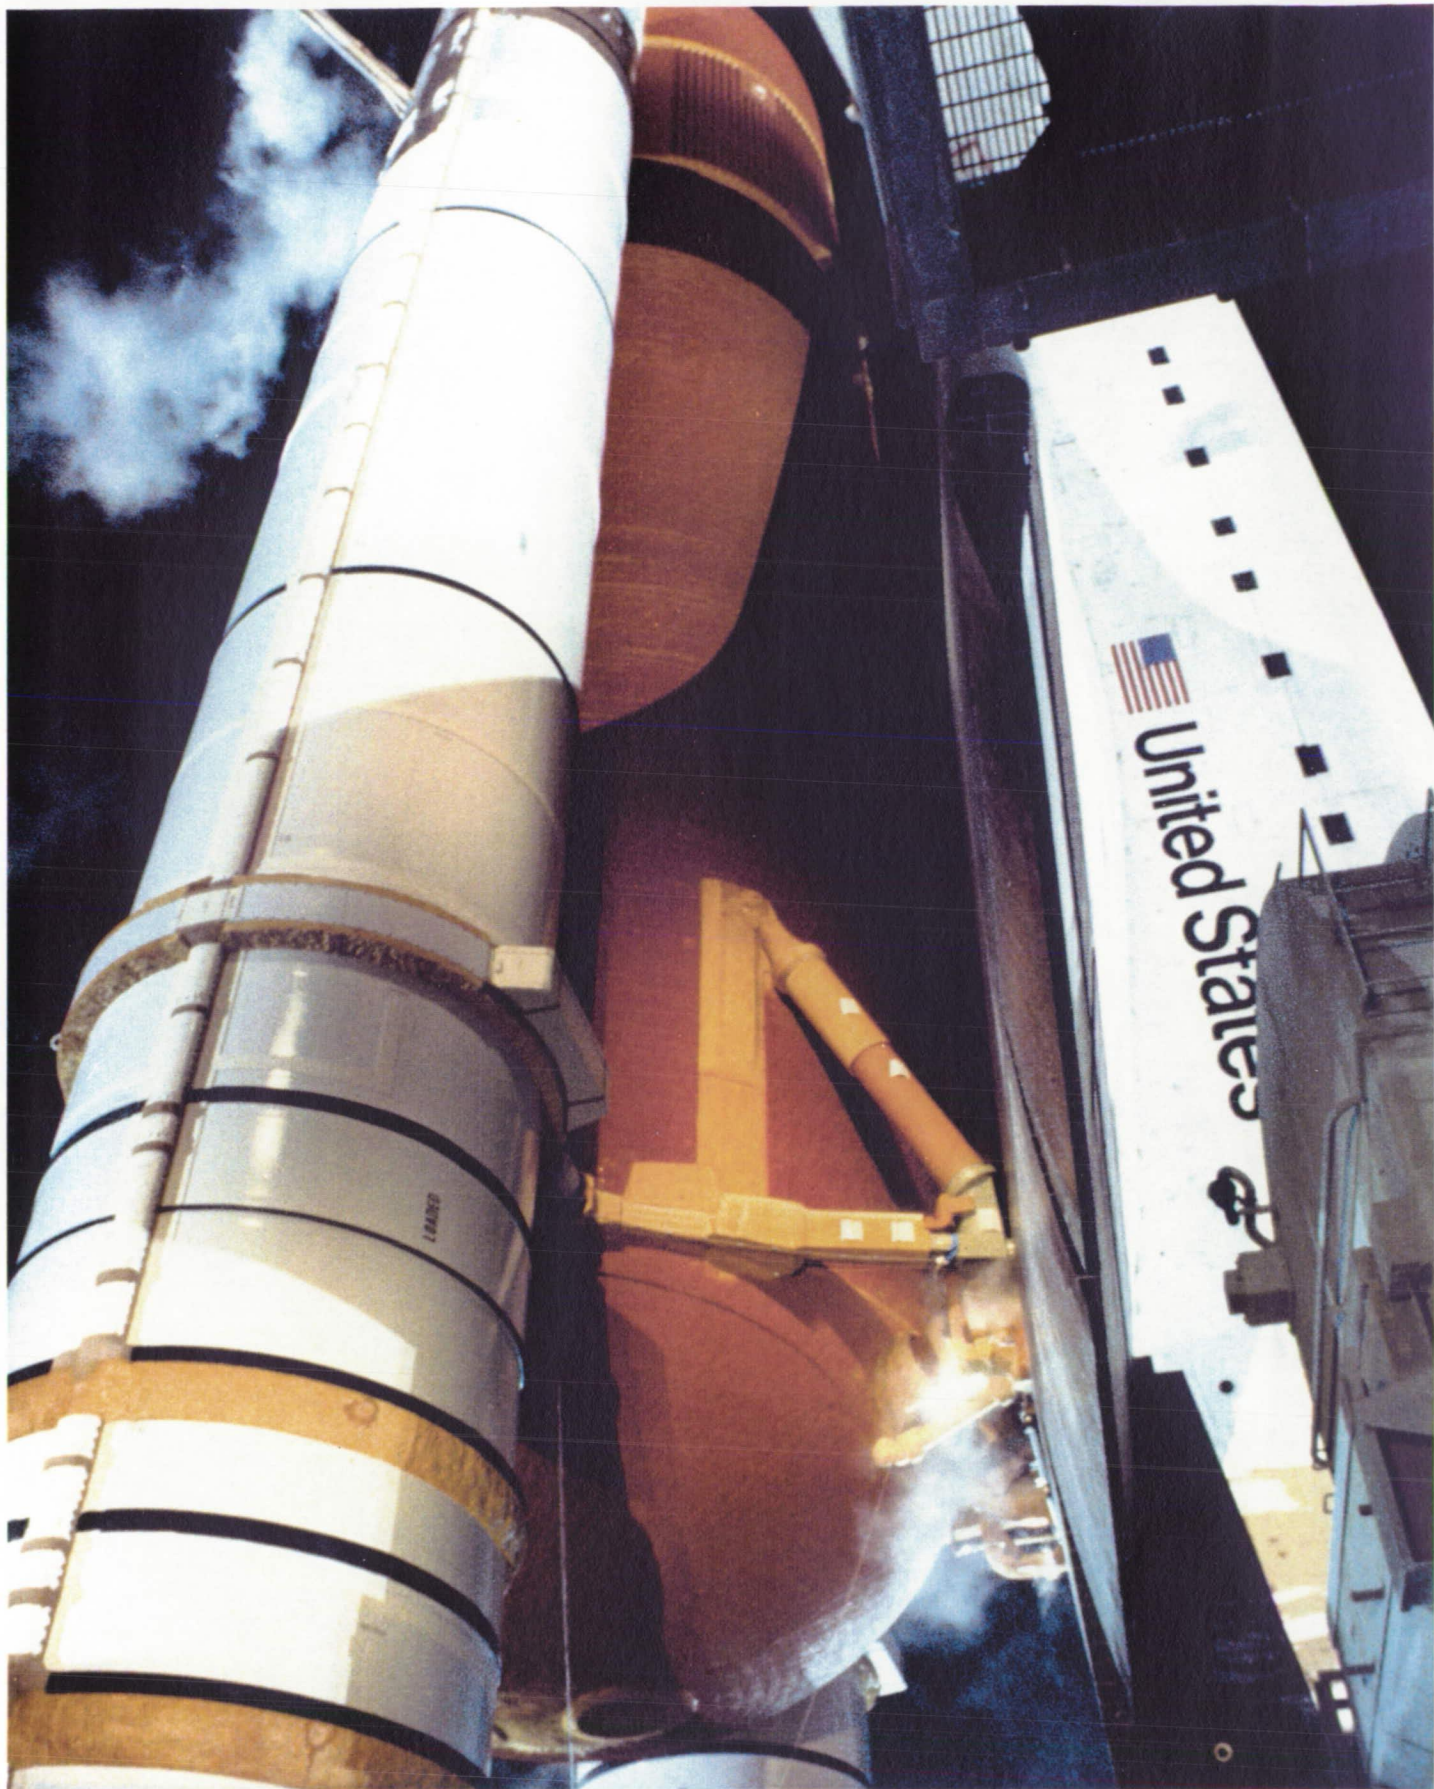
Light condensate, but no ice or frost accumulation, was present on the LH2 tank and aft dome TPS acreage

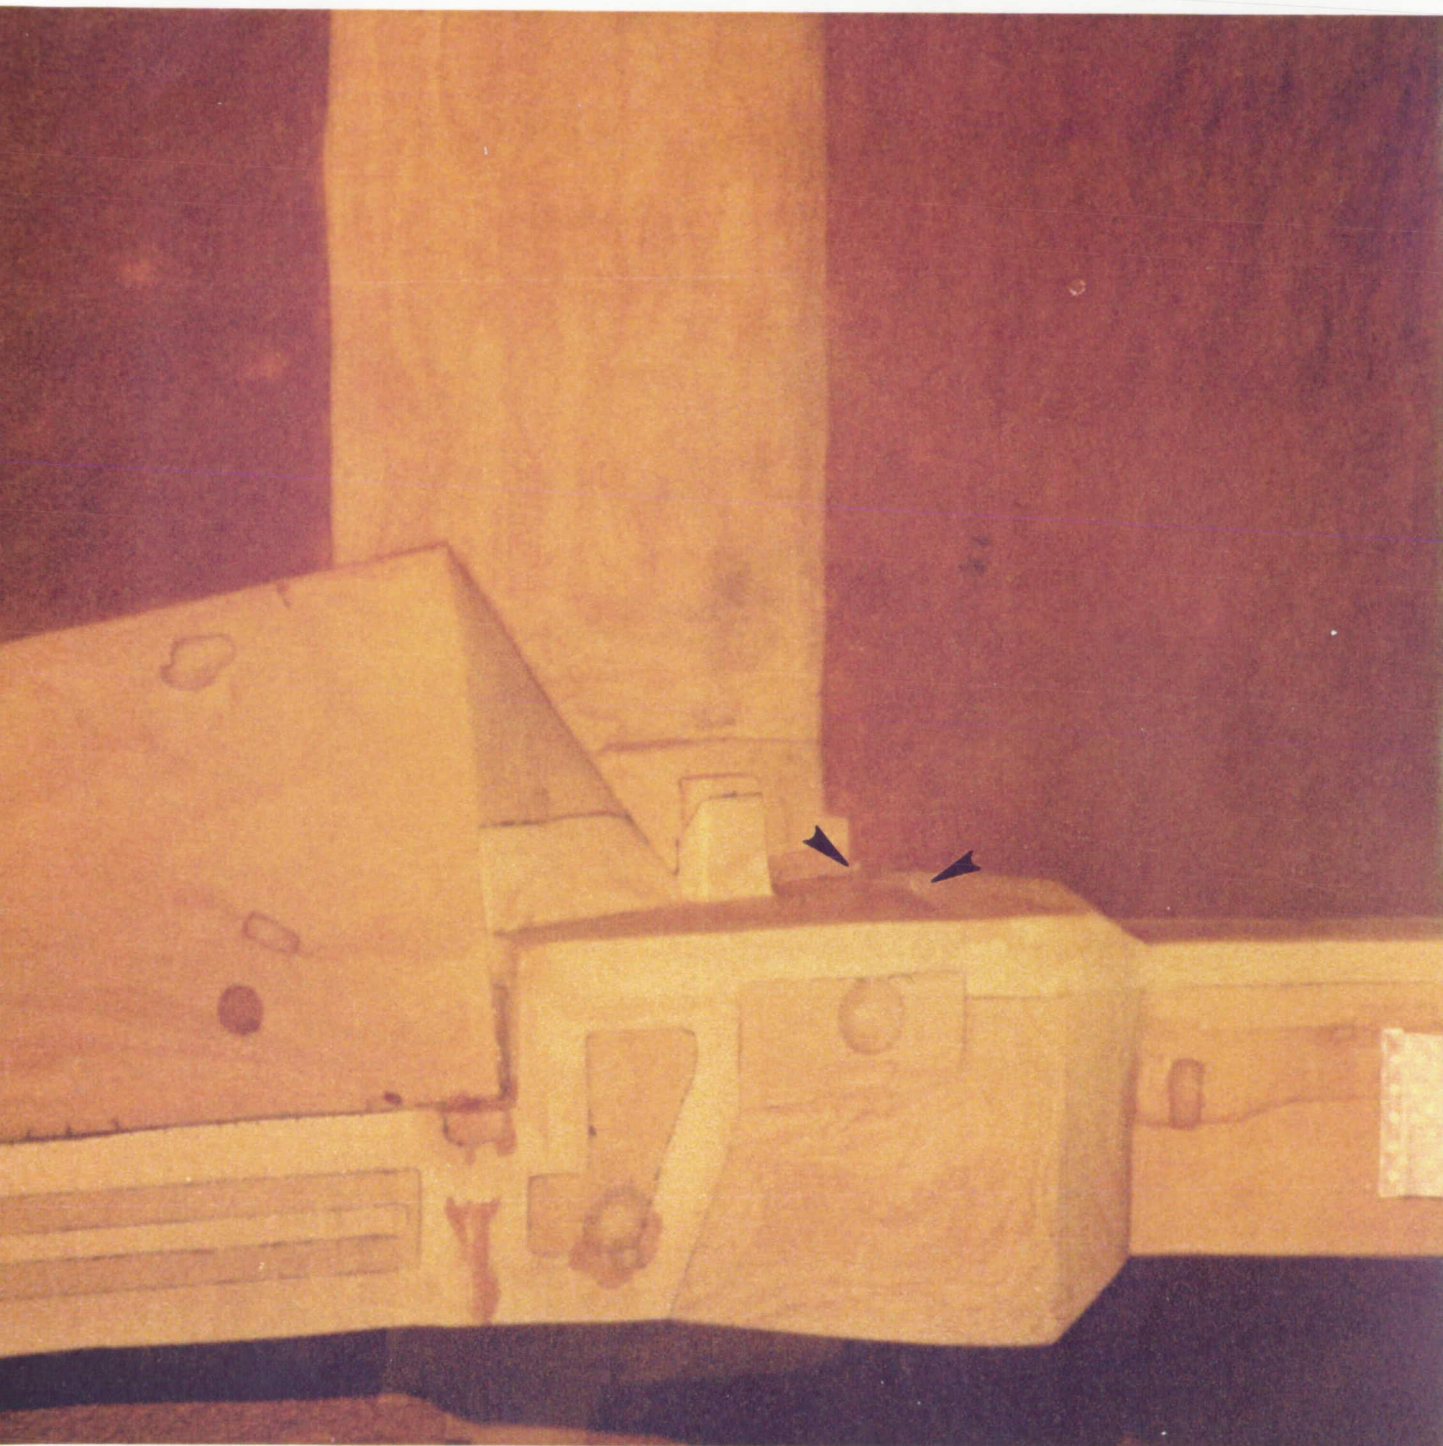
Anomaly 002 and PR ET-48-TS-0027 documented two cracks (8 and 4 inches, respectively, and 1/4-inch wide) in the forward surface TPS covering of the -Y vertical strut cable tray near the longeron closeout interface. Both cracks exhibited no offset and were not filled with ice or frost. Due to the proximity of

the cracks, the possibility existed for loss of BX-250 TPS in flight. Thermal and flow field analyses showed no aerothermal or debris concerns.

Two cracks, 8 and 4 inches long, respectively, appeared in the LH (-Y) vertical strut/cable tray forward facing TPS covering near the longeron closeout interface. A stress relief cut in the TPS to allow for structural movement had been deleted by design.

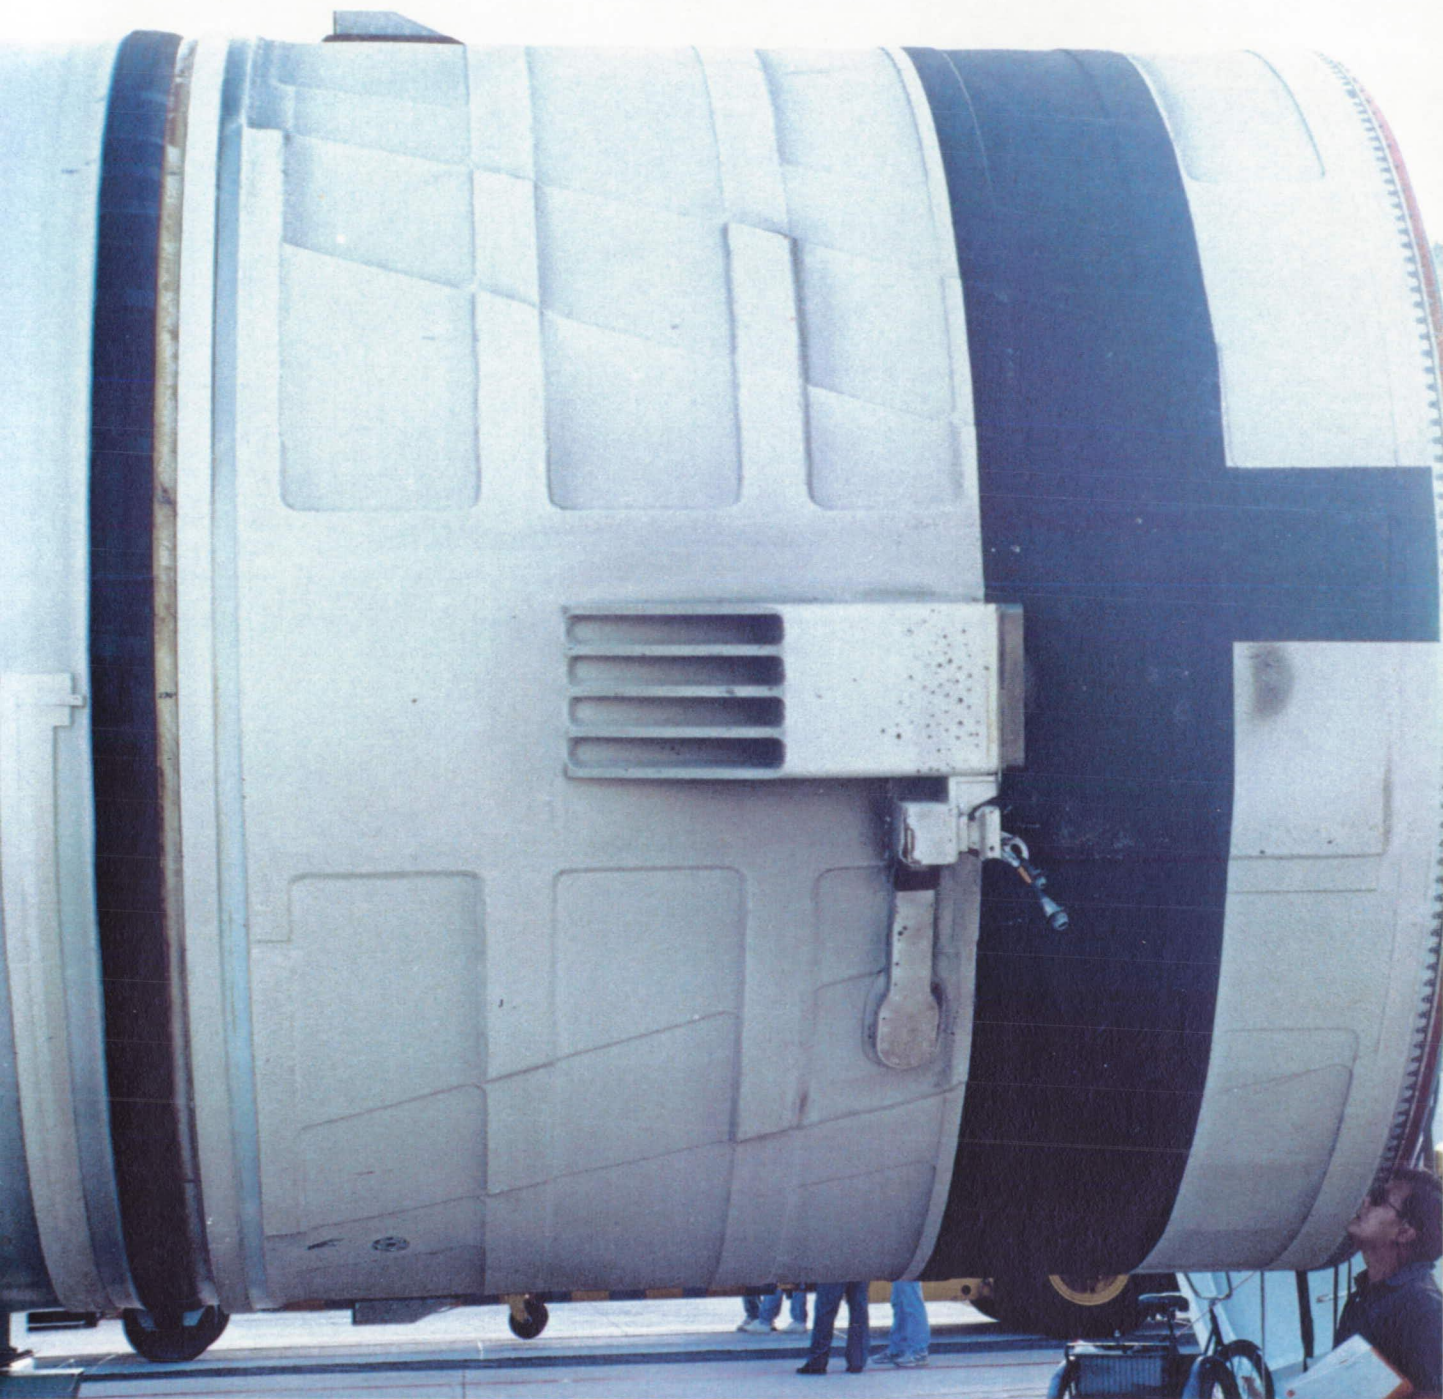
The LH forward skirt exhibited no MSA-2 debonds or missing TPS.
Both RSS antenna covers/TPS were intact and undamaged.

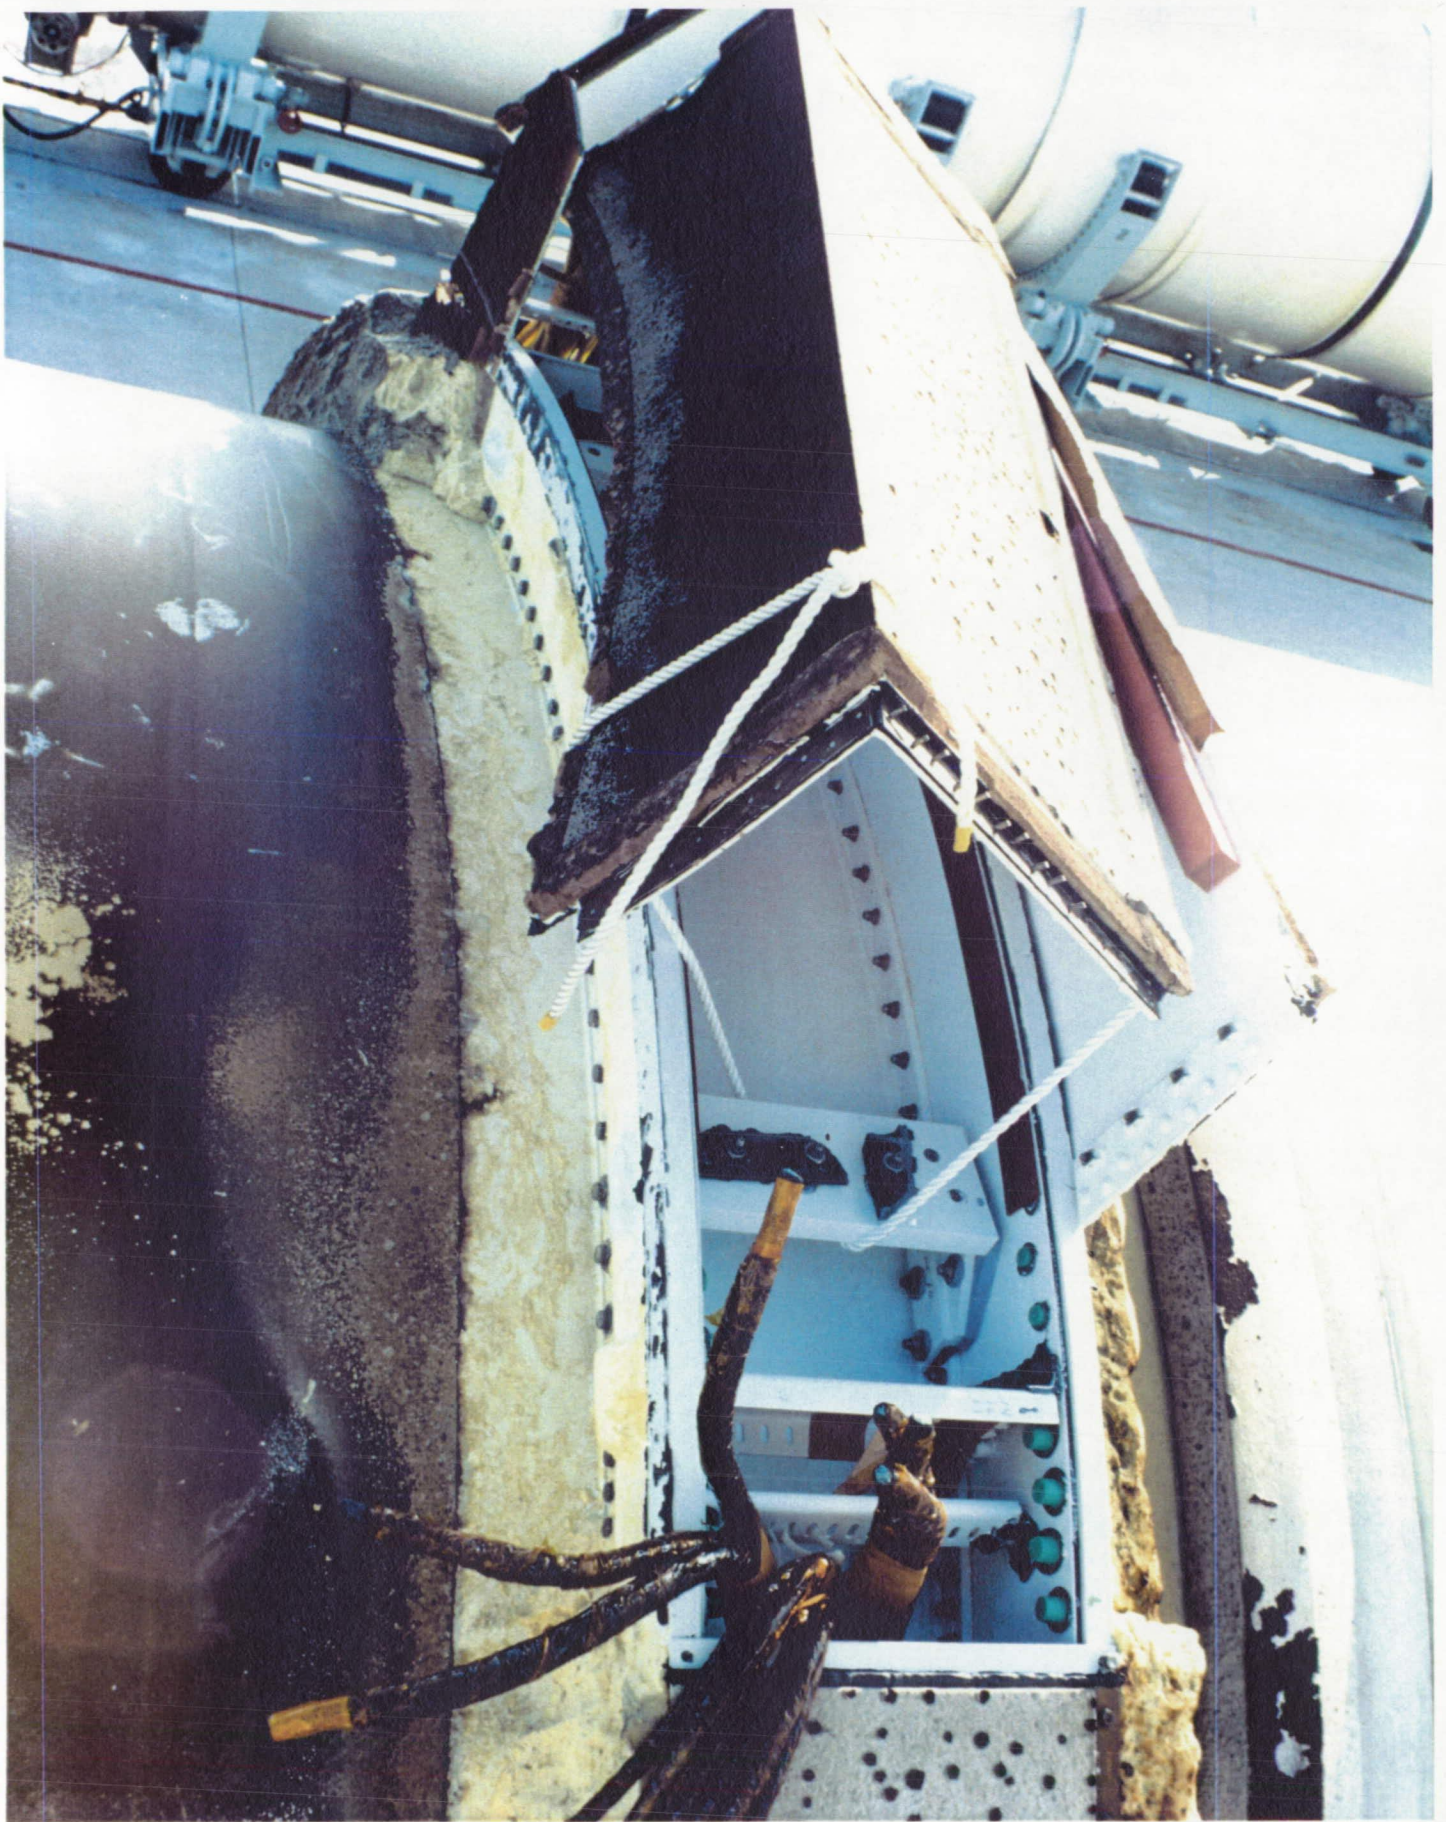
Close-in view of water impact damage to the ETA ring, IEA, and IEA covers. This type of damage was not a debris concern.

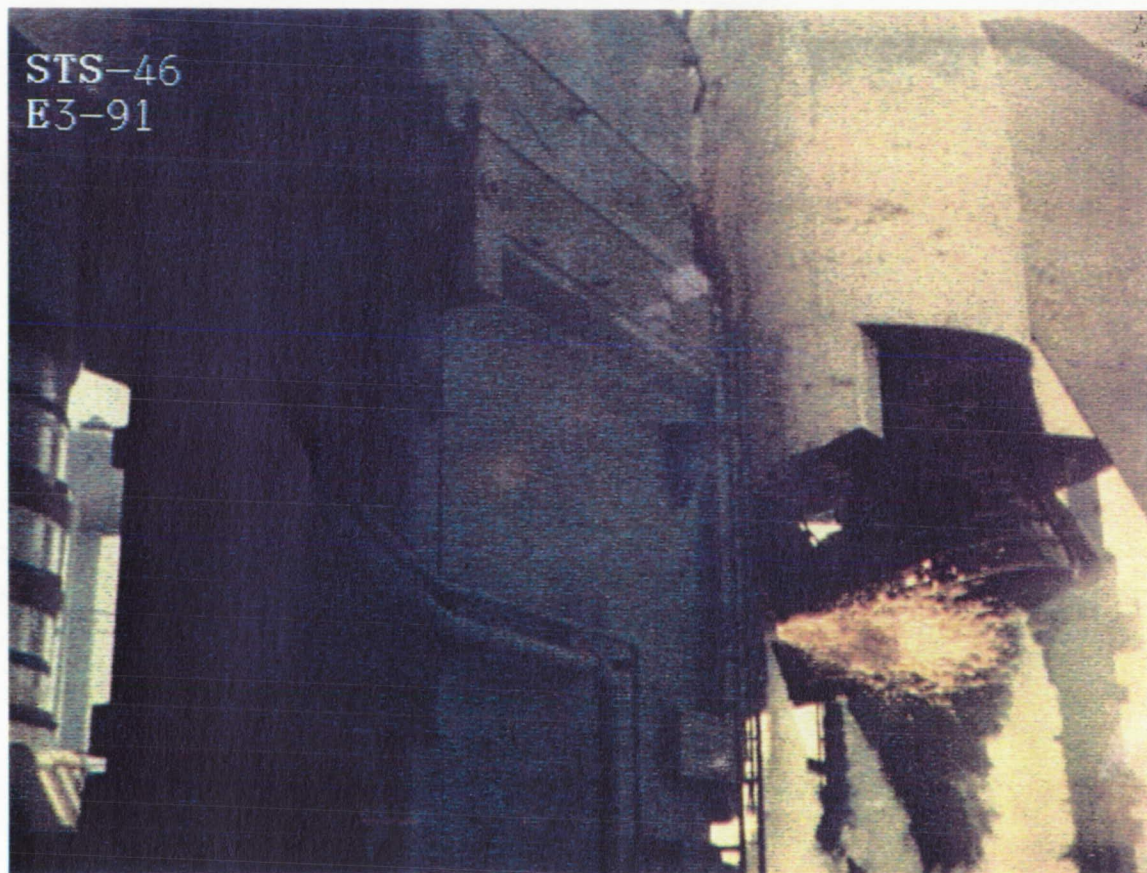
Figure 2.2.1 Premature Firing of Hydrogen Igniter

The southwest hydrogen igniter on the LH2 TSM fired too fast and ended prematurely (before SSME startup). The southwest hydrogen igniter stopped firing at T-8.634 seconds as read from the Camera E-3 film. No follow-up analysis is expected.
